Manhole Inspection Summary

Manhole # S37E__034MH

Insp Date: **10/20/08 2:18 PM**

Location Address: **601 e fayette st**

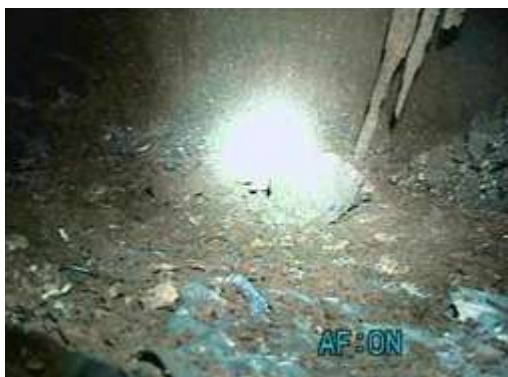
Defect 4

Condition: ☐ Sound ☐ Cracked ☐ Root Intrusion ☐ Deteriorated ☐ Leaks ☒ **Debris**

channel debris

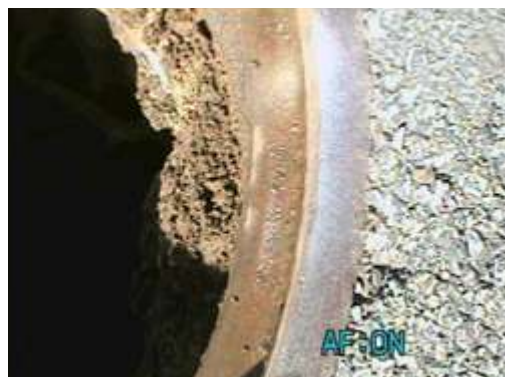
Defect 3

Offset: **3** (in.)

offset

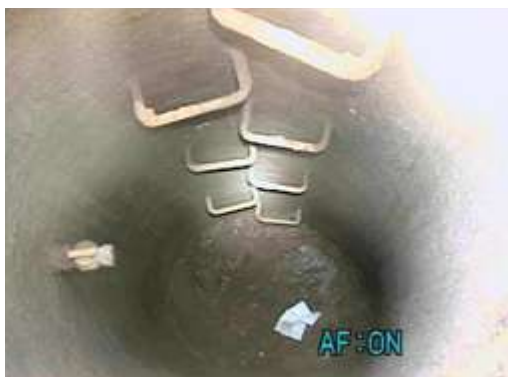
Defect 2

Count: **7** Missing: **0** ☒ **Corroded**

cor. steps

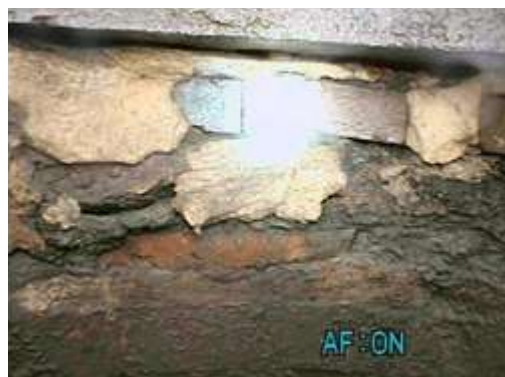
Defect 1

Condition: ☐ Sound ☒ **Cracked** ☐ Root Intrusion ☒ **Loose Brick** ☒ **Deteriorated**

chimney cracked, loose brick, & deteriorated

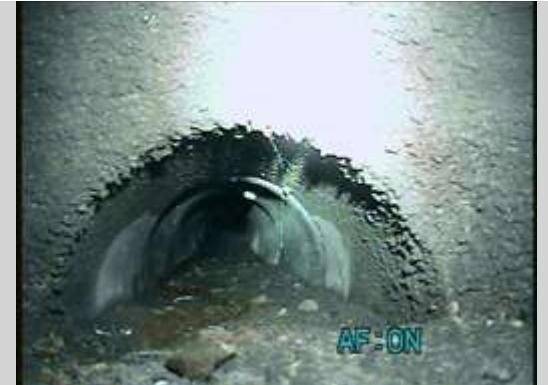
12 O'Clock Outflow

Deposits: ☐ None ☐ Mud ☐ Sludge ☒ **Debris** ☐ Grease

Silt Depth: 0 (in.) Deposits Extent: **Heavy**
